The digital 3D reconstruction of the 18th c. Bloemstraat and Eerste Bloemdwarsstraat

4D Research Lab Report Series 3

A 3D reconstruction of the 18th century situation in the Bloemstraat and Eerste Bloemdwarstraat, two narrow streets in the Amsterdam Jordaan neighbourhood, was made as a virtual space for visualisation and analysis of social patterns in historic street life. This report discusses the creation of the digital 3D model.

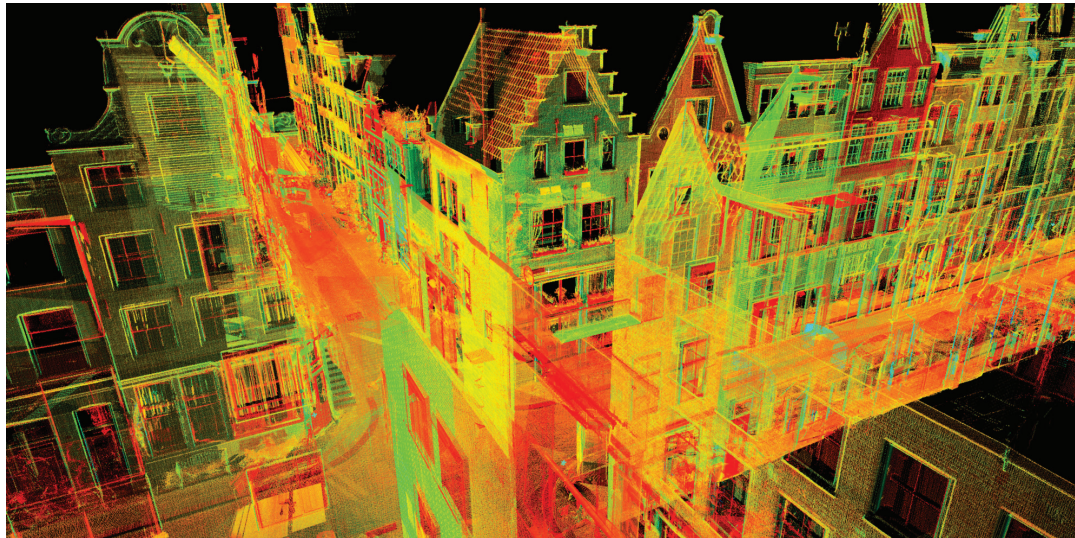
Figure 4. Screenshot of part of the scan data made in Leica's Cyclone software.

On the 14th of April 2020 a LiDAR (laser) scan was made of the selected parts of the Bloemstraat and Eerste Bloemdwarsstraat. The 4DRL's Leica p30 was used. No colour data was captured. The required scan data was roughly cleaned up and cut out from the raw data. Two exports were made, one set with high resolution data (.p57 format, point distance 2-3mm), and a lower resolution dataset to be used as modelling base (.ply format, average point distance 1 cm).

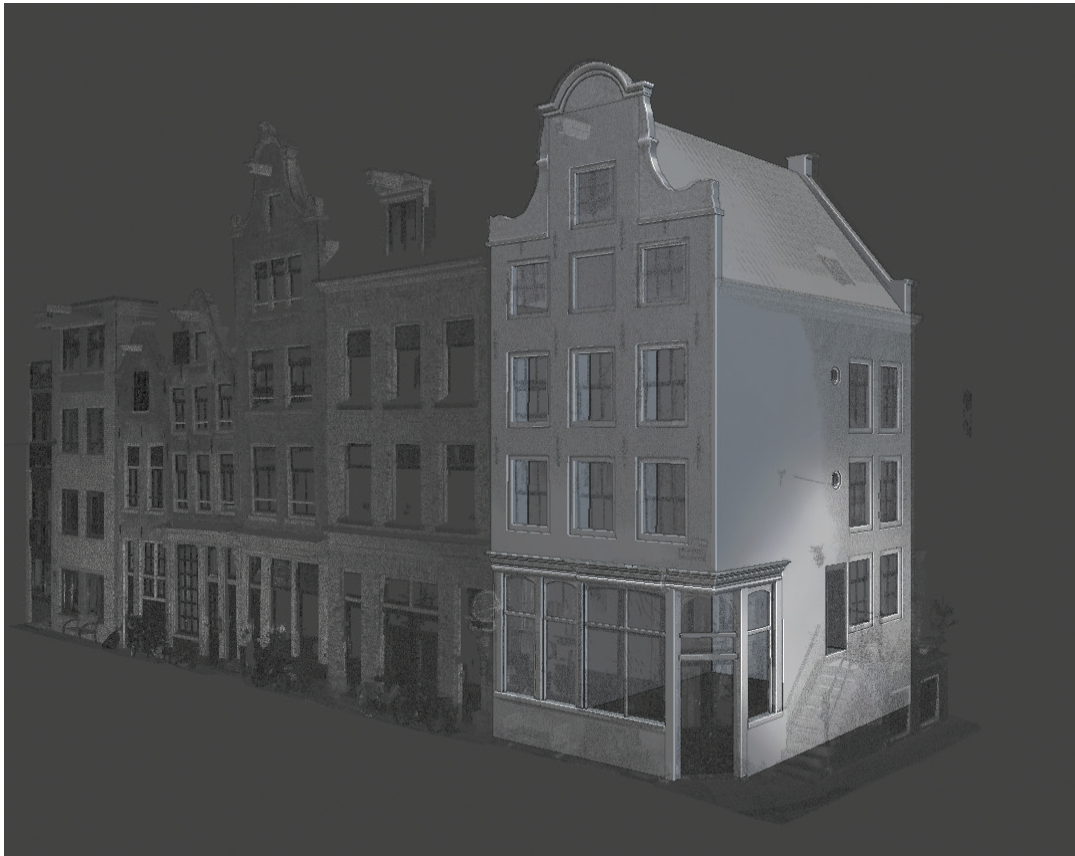
Figure 8. Example of modelling based on the point cloud data.

All relevant data was combined in Blender, the 3D modelling software used for this purpose. A low-resolution version of the point cloud data (1cm) was used to improve handling speed in the viewport (Figure 8). The historical images were prepared in gimp (image editing software): the perspective was corrected, and the images were scaled in relation to an orthographic projection of the point cloud, after which they were loaded in Blender (Figure 9). As this is a manual process, this results in somewhat less accurate models than those based on the point cloud. Also, lens deformation affects the accuracy of the reconstructions to a small degree. Lens correction is not a solution here as the model of the camera and lens are unknown.

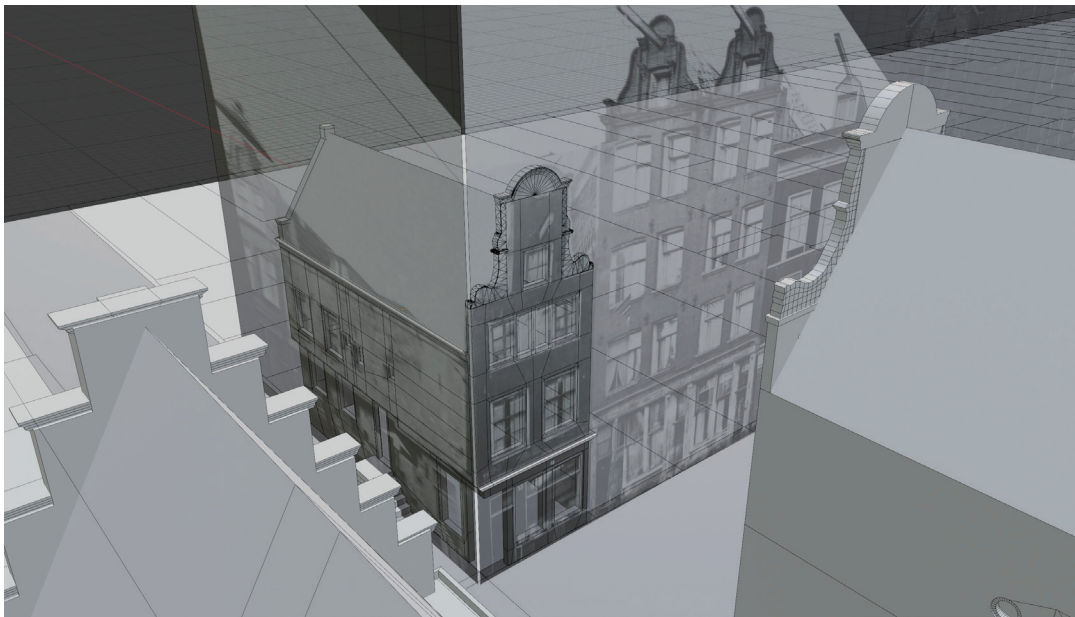
Figure 9. Example of modelling based on ortho corrected historical photography.
