# **The digital 3D reconstruction of the 18<sup>th</sup> c. Bloemstraat and Eerste Bloemdwarsstraat**

4D Research Lab Report Series 3

A 3D reconstruction of the 18<sup>th</sup> century situation in the Bloemstraat and Eerste Bloemdwarsstraat, two narrow streets in the Amsterdam Jordaan neighbourhood, was made as a virtual space for visualisation and analysis of social patterns in historic street life. This report discusses the creation of the digital 3D model.

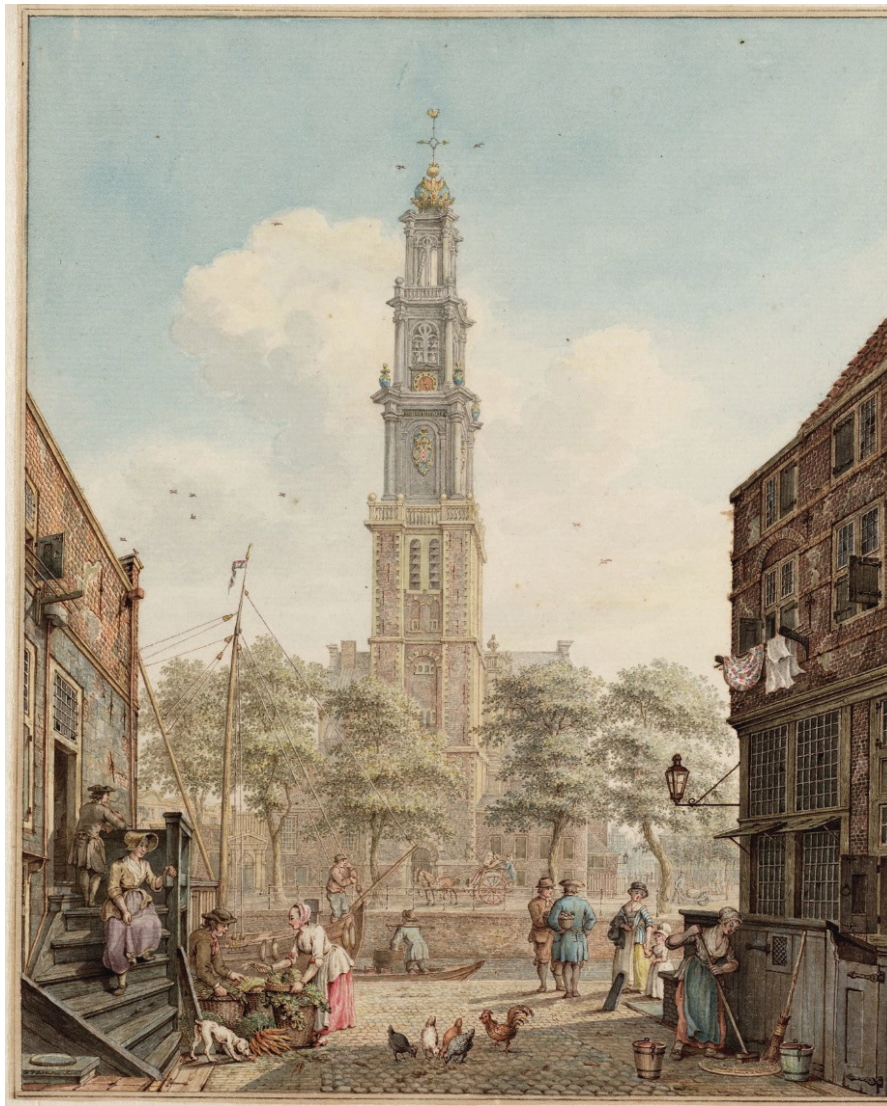
*Figure 1. 18<sup>th</sup> century drawing of a street scene at the beginning of the Bloemstraat looking towards the Westerkerk (Drawing: H.P. Schouten, 1772/Stadsarchief Amsterdam).*

The Bloemstraat is one of these streets (Figure 1, Figure 2). Positioned in between two main canals, the Bloemgracht and former Rozengracht (now a street), the Bloemstraat is a secondary street, not located on one of the main communication routes. It is crossed by two shorter streets, the Eerste and Tweede Bloemdwardsstraat, that form the connection between the Bloemgracht and the Rozengracht. The Bloemstraat lines up exactly with the Westerkerk across the Prinsengracht. As a result, this church visually dominates the views out of the street.

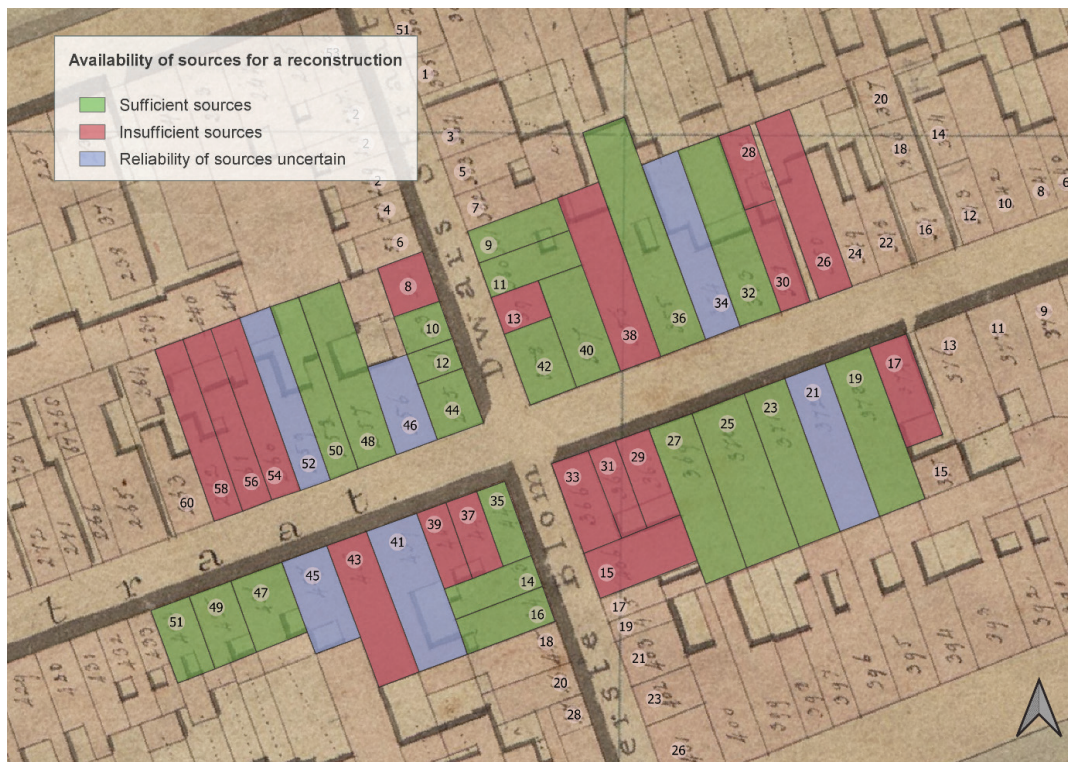
Figure 3. The reconstructed segments of the Bloemstraat and Eerste Bloemdwarsstraat (image based on GIS mapping in QGIS).

Based on an initial assessment of the historical data, a selection of houses was made that could be reconstructed to an 18<sup>th</sup> century phase with some degree of reliability (Figure 3). In the figure, the red plots are houses constructed after the 18<sup>th</sup>

century and for which no good historical image data could be found. The green plots represent houses that currently still have a large number of original elements, or for which reliable historical evidence could be found. These are the houses that have been modelled in detail, while the other houses were modelled as generic volumes in order for the viewer to perceive a continuous urban structure.

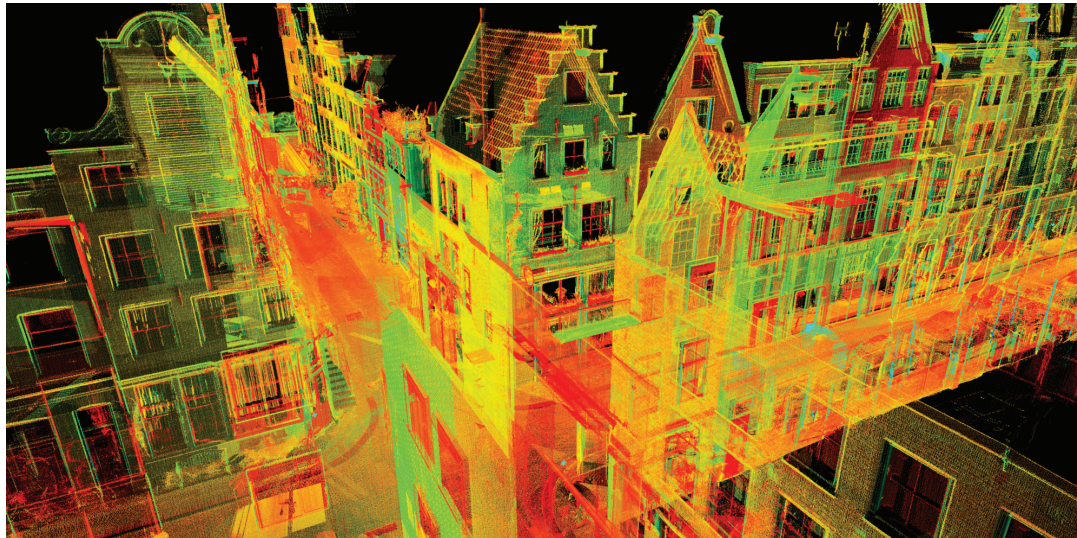
Figure 4. Screenshot of part of the scan data made in Leica's Cyclone software.

On the 14<sup>th</sup> of April 2020 a LiDAR (laser) scan was made of the selected parts of the Bloemstraat and Eerste Bloemdwarsstraat. The 4DRL's Leica p30 was used. No colour data was captured. The required scan data was roughly cleaned up and cut out from the raw data. Two exports were made, one set with high resolution data (.p57 format, point distance 2-3mm), and a lower resolution dataset to be used as modelling base (.ply format, average point distance 1 cm).

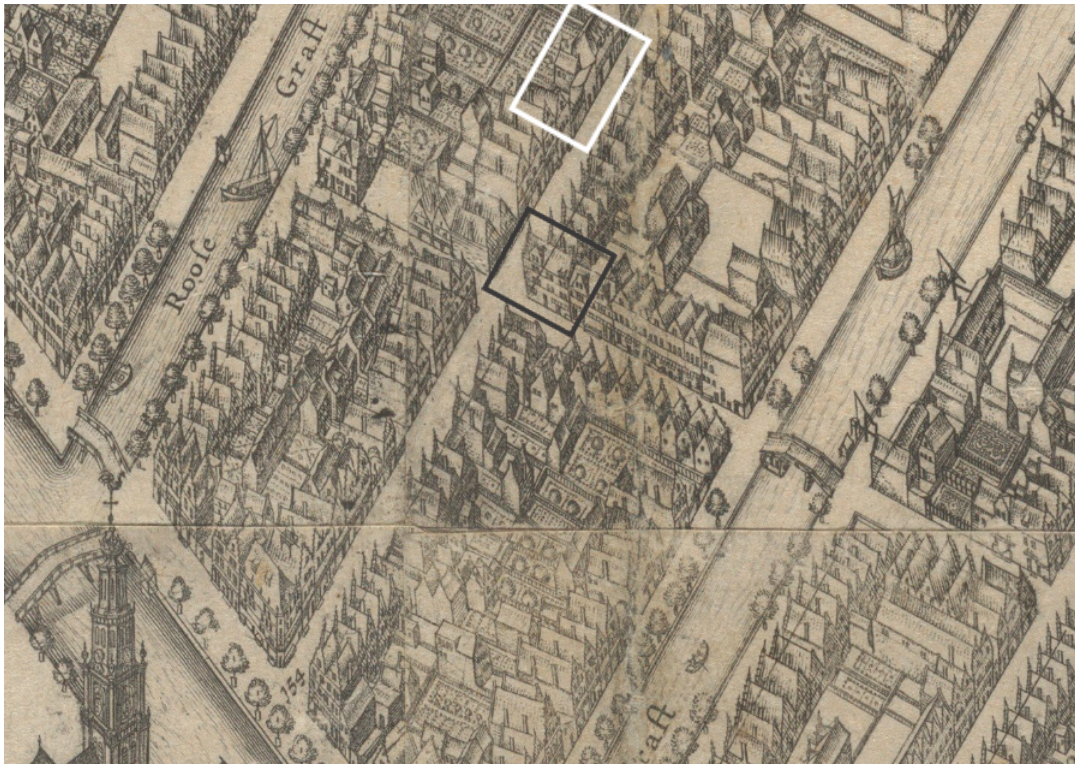
Figure 5. Portion of Balthasar Florisz. van Berckenrode's map of Amsterdam zoomed onto the Bloemstraat and Eerste Bloemdwarsstraat. Outlined in white the later location of the Mennonite church. Outlined in dark grey Bloemstraat 44, with a different window division on the side than the current 18<sup>th</sup> century building (image: Stadsarchief Amsterdam).

Before that date, the only other historical depiction of this segment of the Bloemstraat is on Balthasar Florisz. Berckenrode's map of Amsterdam, originally published in 1625 (Figure 5).<sup>3</sup> Although van Berckenrode's map saw several reprints, the last one being in 1657, the Bloemstraat area was never updated to a more recent situation. Although van Berckenrode generally depicts individualised buildings with reasonable accuracy, the Mennonite church building as seen on the 18<sup>th</sup> century drawings, and with a founding date of 1640, is not depicted on the 1657 map.

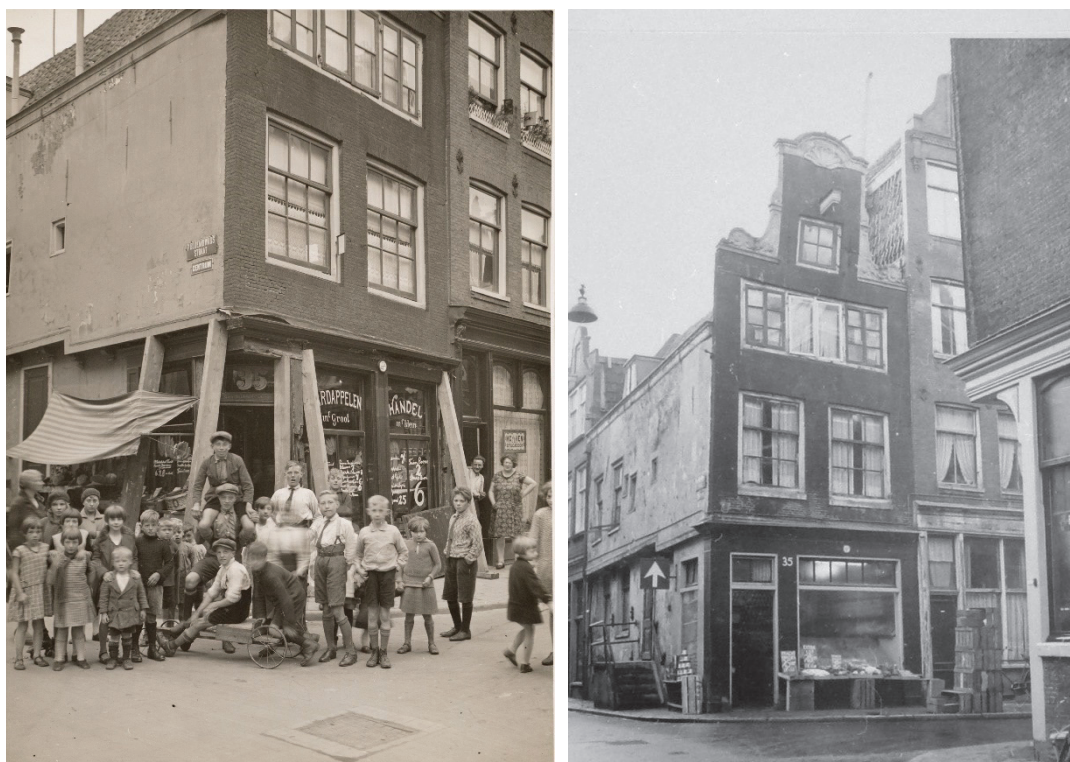
Figure 6. Example of modifications to a house (Bloemstraat 35). Original building with late 17th/early 18th century gable. To the left photo dating to 1930, with a lower facade timber frame probably dating the 19th century suffering from structural problems. To the right a photo from the 1950s, showing the replaced lower facade with a different window and door configuration (both images: Stadsarchief Amsterdam<sup>4</sup>).

the same house, can reveal considerable differences (Figure 6). Especially the ground floor facade, often a timber frame structure supporting the masonry of upper floors, was regularly replaced. The oldest lower facades still surviving today or on photographs are therefore dated in the 19<sup>th</sup> century on stylistic grounds. A possible exception is Bloemstraat 42, which may have an original 18<sup>th</sup> century lower facade frame.

- Corner house on cross-section with Eerste Bloemdwarsstraat.
- Currently modern houses dating to 1980s/1990s.
- 1930s and 1950s photos show largely authentic 17<sup>th</sup>/18<sup>th</sup> c. house with neck gable and a first floor with an overhang on the side, typical of the period.

- Lower facade replaced during 20<sup>th</sup> c. Structural instability visible on 1930s photos. Compare 1930s and 1950s photos. Architrave wooden frame lowered. Doorway changed from corner doorway to front facing doorway. Window size changed.

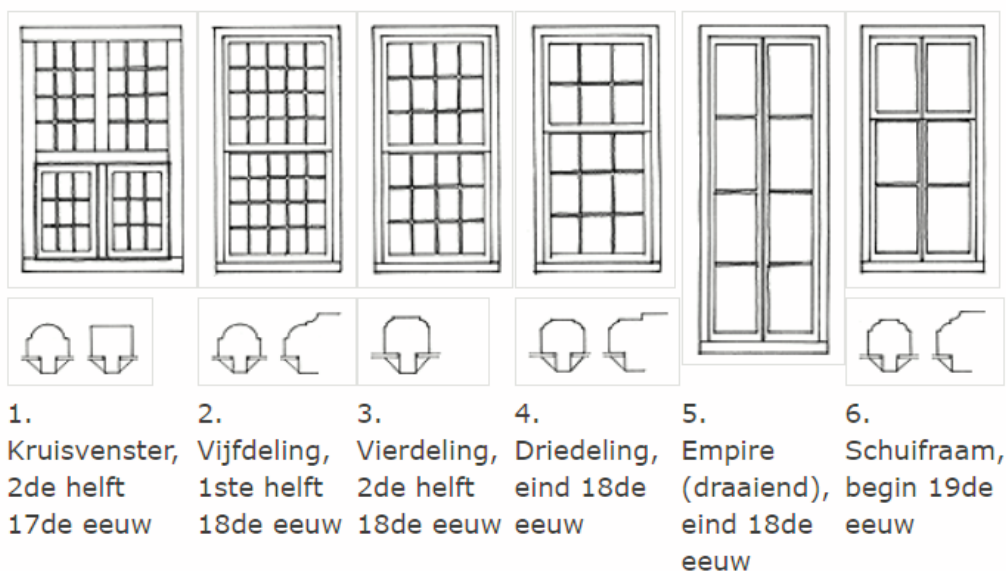
Figure 7. Window typology illustrating the chronological evolution of window panel size (illustration: Rouwhorst 2005).

However, generally we can assume that timber elements have a higher replacement rate than brick elements, and are therefore expected to be newer. This is valid for the window frames, and especially the panel division as indicated by the rods. In none of the cases the original 18<sup>th</sup> century window frame panel size is preserved (Figure 7).

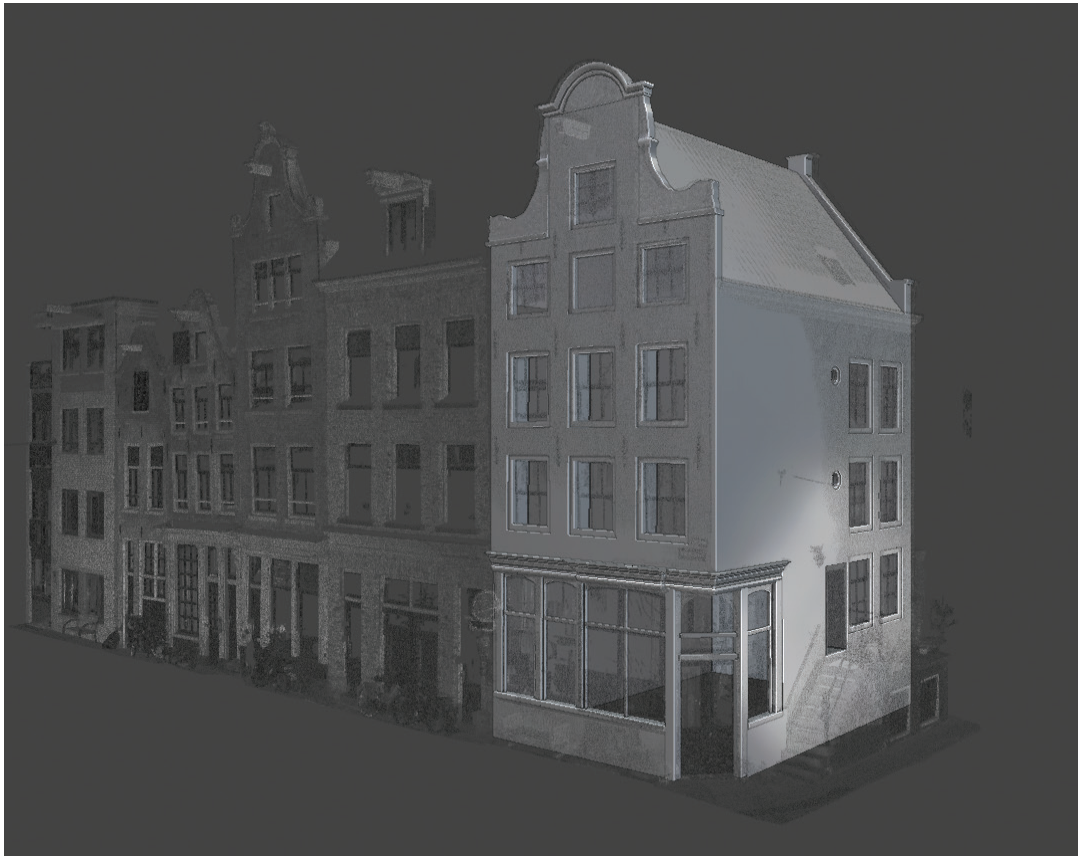
*Figure 8. Example of modelling based on the point cloud data.*

All relevant data was combined in Blender, the 3D modelling software used for this purpose. A low-resolution version of the point cloud data (1cm) was used to improve handling speed in the viewport (Figure 8). The historical images were prepared in gimp (image editing software): the perspective was corrected, and the images were scaled in relation to an orthographic projection of the point cloud, after which they were loaded in Blender (Figure 9). As this is a manual process, this results in somewhat less accurate models than those based on the point cloud. Also, lens deformation affects the accuracy of the reconstructions to a small degree. Lens correction is not a solution here as the model of the camera and lens are unknown.

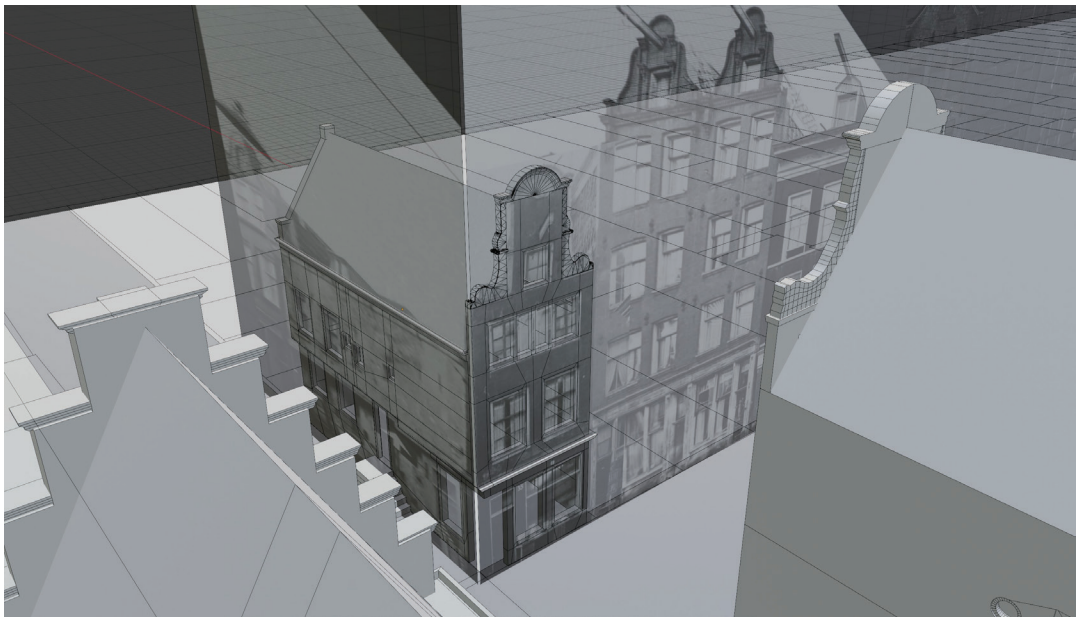
*Figure 9. Example of modelling based on ortho corrected historical photography.*

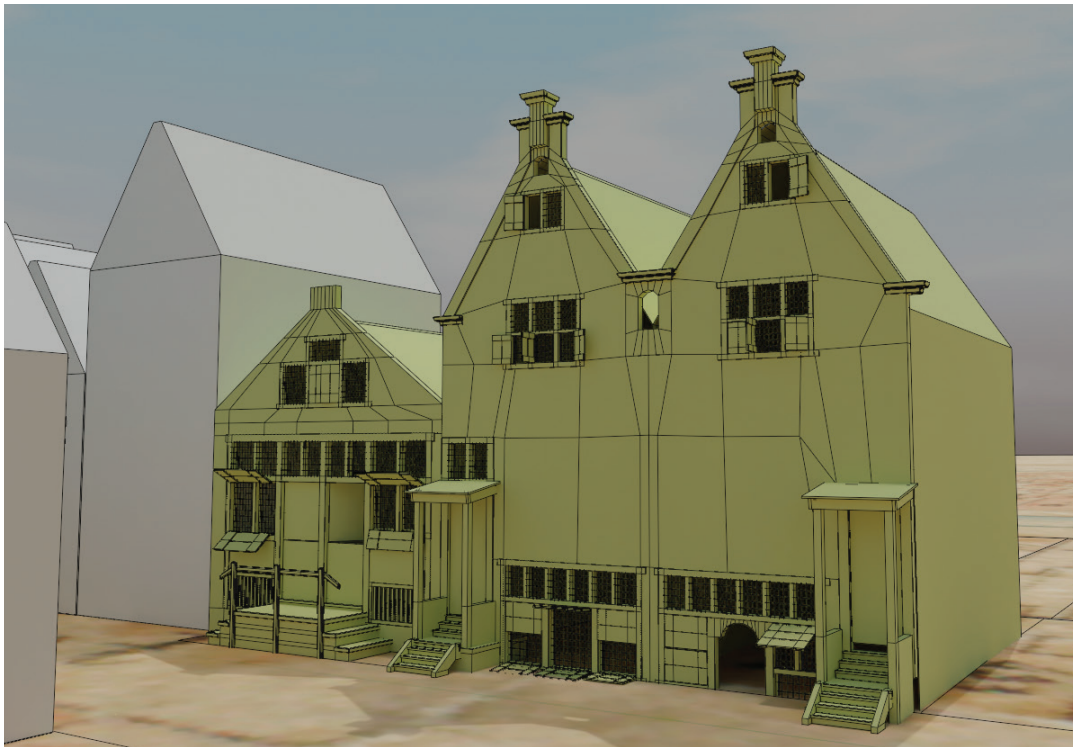
*Figure 10. Reconstruction of the Mennonite church building, and low timber house next to it dating to the period 1640-1728.*

- Currently two 20<sup>th</sup> c. houses in historicising style.
- Former Mennonite church, 1640-1728.
- Model based on 18<sup>th</sup> c. drawings of the Mennonite church, numbers 49-51, one dating to 1729 by Pronk (<https://archieff.amsterdam/beeldbank/detail/142eb909-edf8-ddd9-7e84-02c8dcd97416>) and one to 1780 by Verstegen/Phillips (<https://archieff.amsterdam/beeldbank/detail/69b8f55b-b7a8-3d61-fe33-6e8ec33b9e82>).

- These house numbers had at least two completely different phases in the 18th century, in terms of physical appearance and use. One phase covers the early part until 1728. After the Mennonite church merged with another one, the church building was turned into two regular houses. It is unknown how much was demolished and rebuild, but it seems that the internal structure and height remained largely the same.

- There is a sketch by C. Pronk dated to 1729 that depicts this building in its original state. In 1780, this sketch was used to make ink drawings or etchings by J. Verstegen and published by C. Phillips. However, by that time the building did not exist anymore.

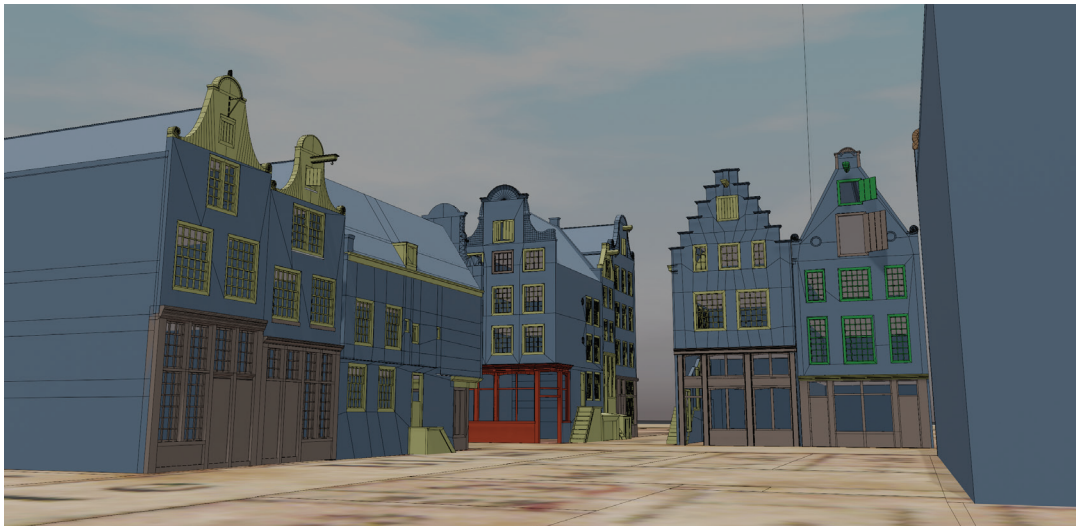
Figure 11. Visualisation of degrees of interpretative certainty.

The model includes a classification of the degrees of certainty resulting from the variation in reliability of source data, and alternative ways of treating gaps in the data. Parts of the models were colour coded according to degree of certainty (Figure 10), following the scheme developed by the 4DRL (Table 2). An explanation and justification of this classification can be found in Lanjouw & Waagen (2021: 17-20).

Certainty Class	Evidence type	Variability	Example	Colour
Certain	Empirical	None	Scanned remains	6A8096
Quite certain	Logical extension	Low	Missing part of relatively complete object	3DAA4F
Moderately certain	Close parallel	Limited	Same type, direct relation	CCC87B
Not so certain	General parallel	Considerable	Same type, indirect relation	968175
Quite uncertain	Historic context	High	General stylistic traditions	A77E58
Very uncertain	Theoretical	Very high	Constructional argument	BA3F1D
